## **GPR RESEARCH IN WOJANÓW RAILWAY TUNNEL, SUDETES MTS., POLAND**

ADAM SZYNKIEWICZ

KART-GEO, WROCLAW, POLAND, ADAM.SZYNKIEWICZ@GMAIL.COM

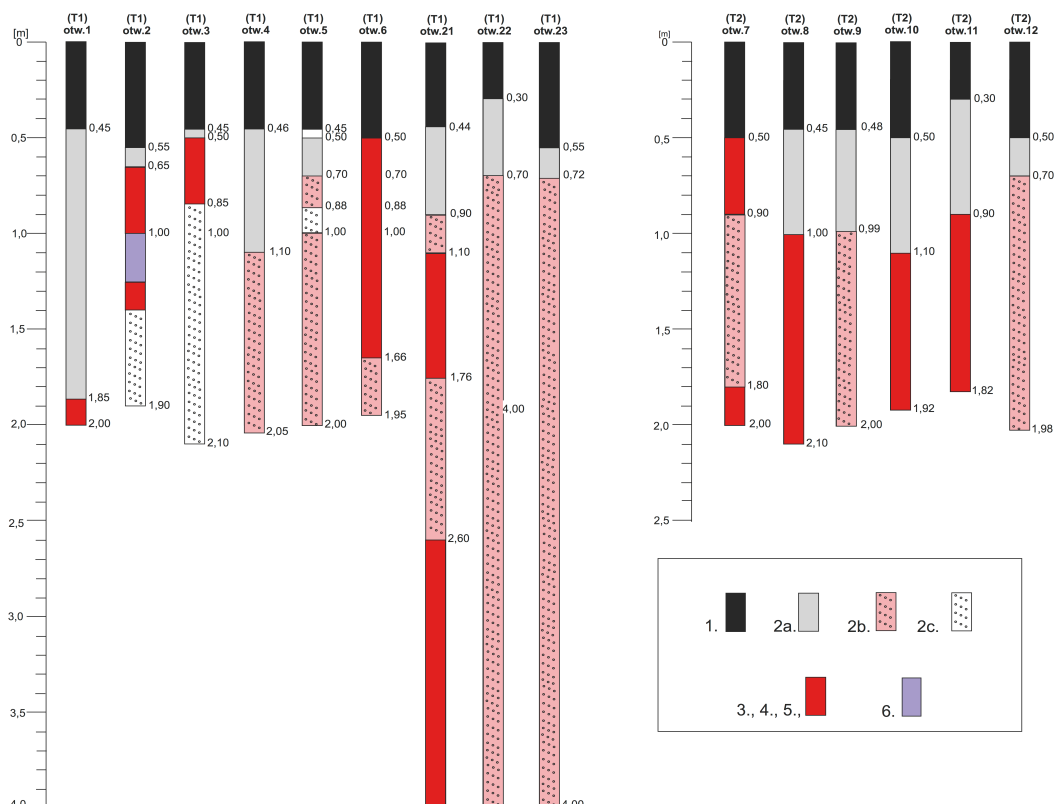
**FIG. 1** – Lithology information about Wojanów tunnel, obtained by drilling its walls. Legend: 1 – housing made of granite rock block; 2a – concrete, cementation zone; 2b – granite weathering (gravel) plus granite fragments; 2c – gravel and sand; 3 – weathered granite; 4 – granite strongly cracked; 5 – solid granite (rare cracks); 6 – aplit.

In the walls of Wojanów tunnel, fifteen horizontal geological drillings were drilled to a depth of 2–4 m (Figure 1). Nine holes were made in the northern wall of the tunnel (from the T1 side) and six in the southern wall of the tunnel (from the T2 side). Geological drilling holes (indicated by “otw.” in Figure 1) were made in the walls at a height of 1, 2, and 3 m above the floor (for borehole locations, see also Figure 2). The drilling shows that the granite blocks of the tunnel casing have a thickness of 30–55 cm. Behind the housing there is a strengthening zone (concrete, cement), which has a thickness up to 1.1 m (in some places up to 2 m). From 0.7 to 4.5 m there are granite debris, gravels and sands. Behind the casing of the tunnel, at a distance of 2–4 m, there is weathered granite, heavily cracked granite, or hard granite with rare cracks.

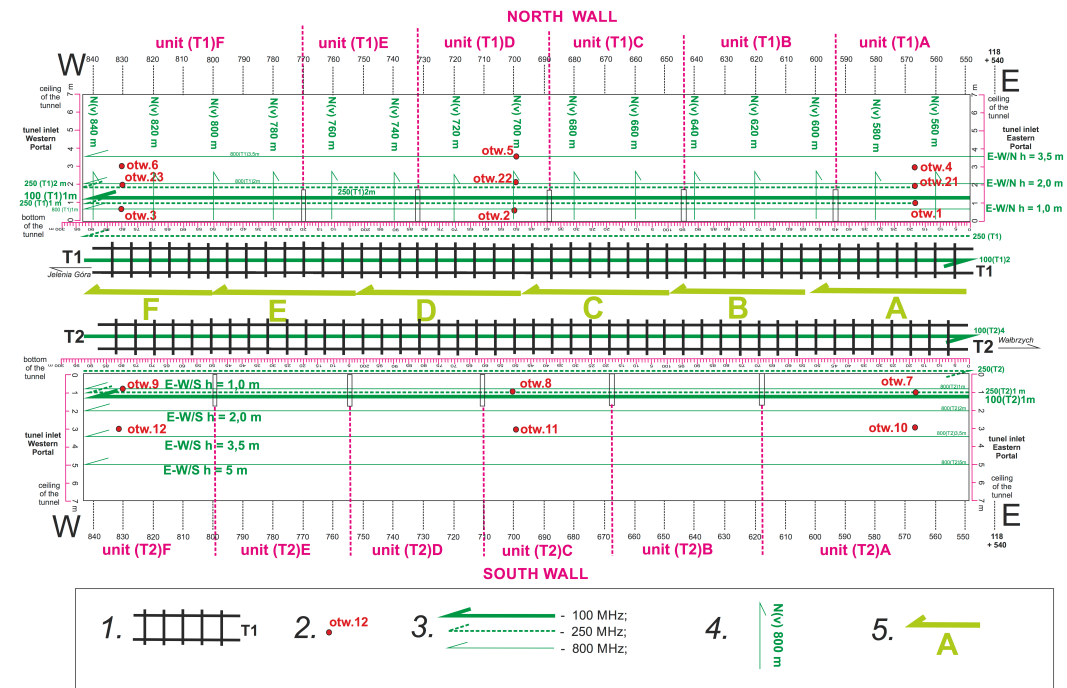
**FIG. 2** – Scheme illustrating the GPR cross-section and borehole locations in Wojanów tunnel. Legend: 1) Tracks; 2) Horizontal boreholes; 3) Horizontal GPR cross-sections; 4) Vertical GPR cross-sections on the northern wall (800 MHz antenna); 5) GPR cross-section on the ceiling (800 MHz antenna).

GPR research was carried out for the purposes of designing the tunnel renovation. To facilitate the description of research results and the identification of rock mass variability occurring behind the housing, the entire length of the tunnel (from the eastern portal towards the western portal) was divided into sections denominated as follows: from (T1)A to (T1)F and from (T2)A to (T2)F (see again Figure 2; note that the kilometers of the railway route are also reported in the scheme).

The following cross-sections were recorded with the use of 100 MHz antennas: over the tunnel, along the walls of the tunnel at a height of 1 m, and on the bottom of the tunnel (between the rails of railway tracks). The following cross-sections were recorded with the use of 250 MHz antennas: along the walls of the tunnel, at heights of 1 meter and 2 meter, along the tunnel bottom and along the base of the walls of the tunnel casing. Finally, cross-sections with the use of 800 MHz antennas were recorded along the tunnel walls, at heights of 1, 2, 3.5, and 5 m, as well as along the ceiling of the tunnel (see Figures 2 and 5).

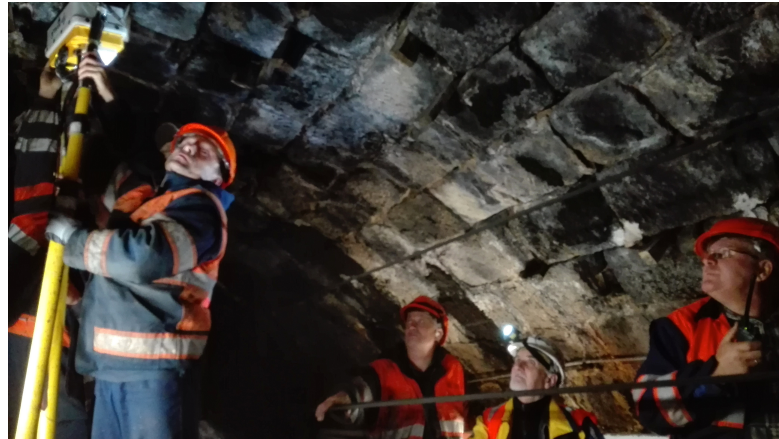
**FIG. 4** – GPR research in Wojanów tunnel: 800 MHz antennas directed towards the ceiling of the tunnel housing.

electric traction. To work at the tunnel ceiling, a train was used which is normally employed to repair the electric traction. All tests were made with antennas facing the tunnel walls (Figure 4). Shielded antennas were used, with three central frequencies: 100, 250, and 800 MHz.

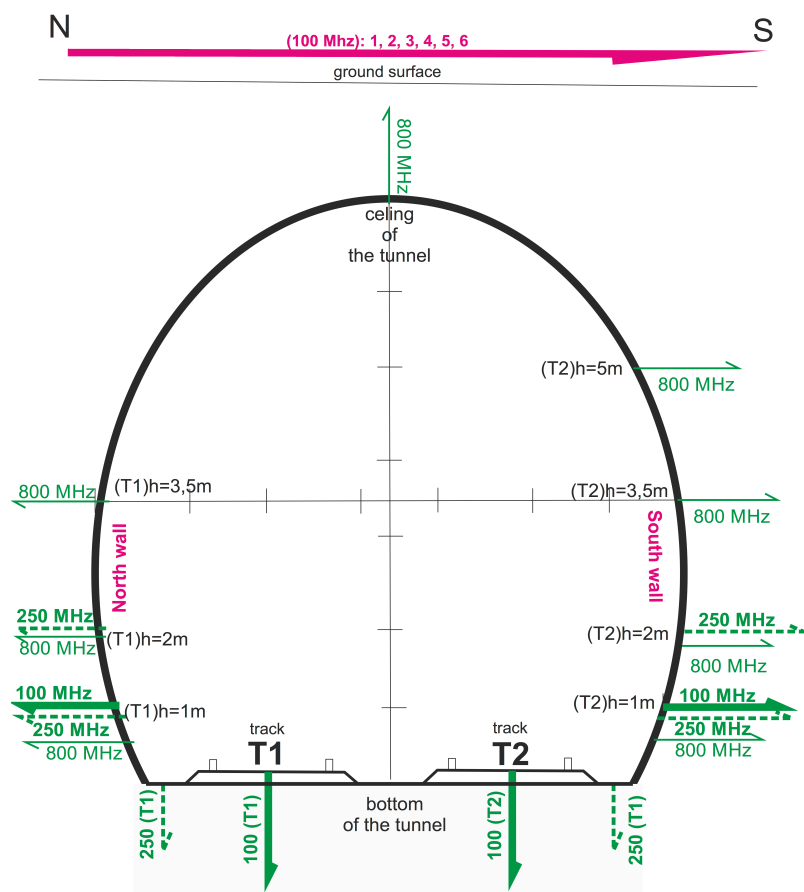
**FIG. 5** – Location of GPR sections in Wojanów tunnel (schematic sketch).

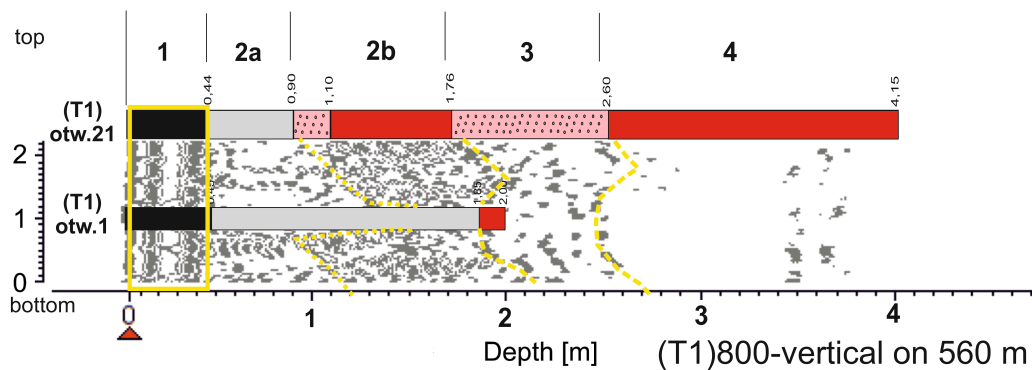
**FIG. 7** – Depth-scale calibration and interpretation of GPR data, by exploiting two geological horizontal drillings in the northern wall of the tunnel, namely drillings (T1)otw.1 and (T1)otw.21. The GPR radargram is (T1)800MHz-vertical, at 560 m. The legend used for the lithology is the same as in Figure 1.

Various color palettes and customary filter combinations were used to analyze GPR data. In Figure 6, an example of processed radargram is presented; this is a fragment of a cross-section recorded with 800 MHz antennas along the north wall, at 1 m height (the (T1) 800\_1m cross-section). By using suitable filters, it was possible to improve the visualization of the gaps in the tunnel casing (radargram A in Figure 6) and of the housing blocks (part B in Figure 6). The calibration of the GPR radargram depth scale was made on the basis of drilling (Figure 7).

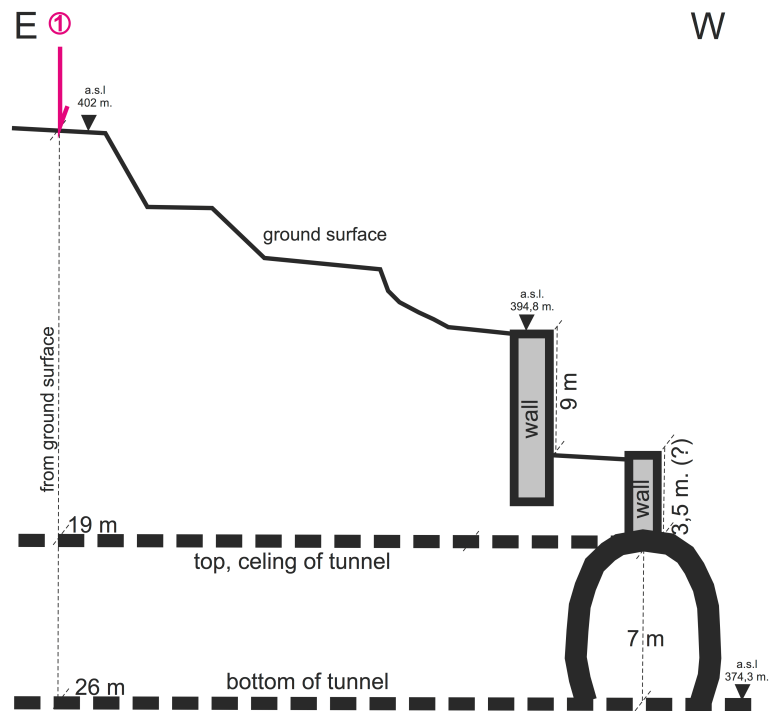
**FIG. 9** – Location of GPR cross-section No. 1 (100 MHz), above the tunnel.

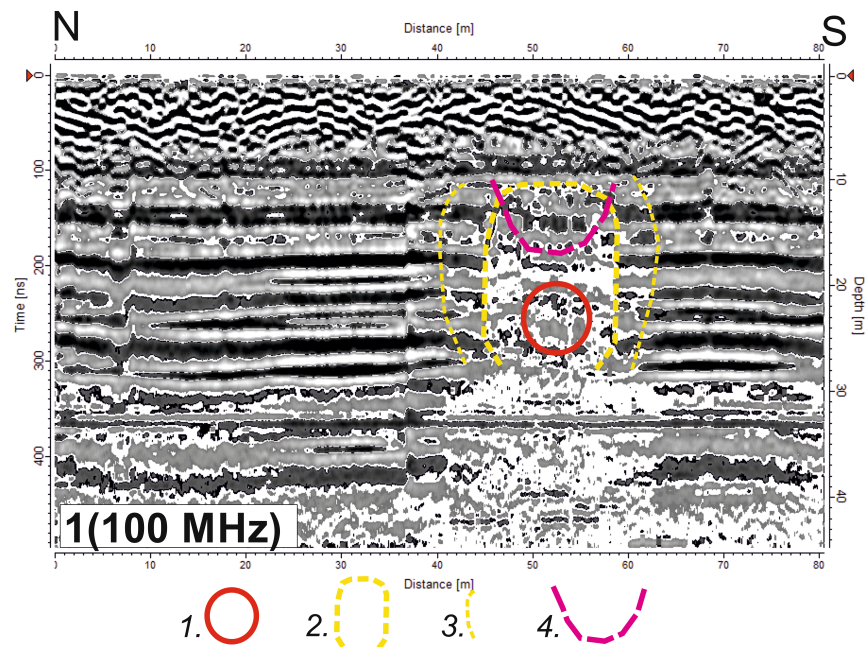
**FIG. 10** – GPR Cross-section No. 1 (100 MHz), above the tunnel. Geological interpretation: 1) Tunnel, 2) Destroyed rock mass, sprinkle, weathered rocks; 3) Granite strongly cracked, weathered; 4) Ground subsidence zone above the tunnel ceiling.

From GPR tests carried out on the surface of the terrain over the tunnel it follows that behind the tunnel casing there is a zone of debris and rubble reaching up to a depth of about 5 m; see Figures 9 and 10 (the rubble and debris region is indicated with 2 in Figure 10). Behind, there is a zone of crumbled (and possibly weathered) granite that reaches

north and south up to about 15 m from the tunnel's axis (indicated with 3 in Figure 10). It was also pointed out that on all cross-sections (made over the tunnel) there are characteristic structures of ground subsidence (4 in Fig. 10).

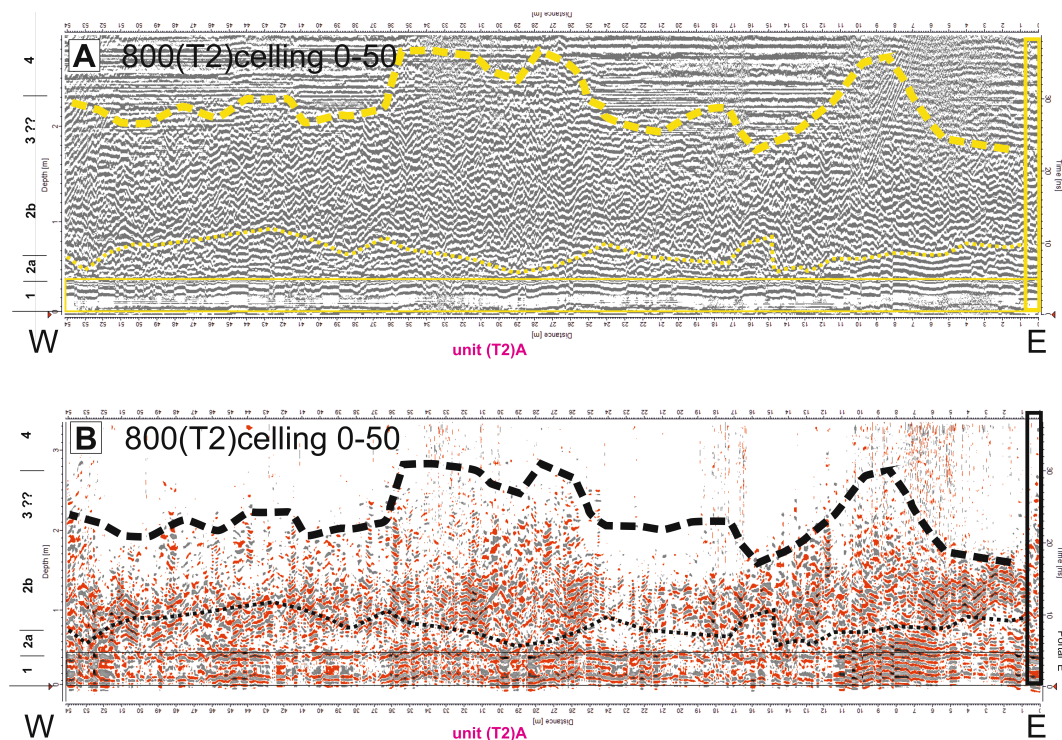
**FIG. 11** – The ceiling of the tunnel: interpretation of GPR data recorded with 800 MHz antennas. Lithology numbers are the same as in Figure 1.

An exemplary fragment of a GPR cross-section recorded on the tunnel ceiling is presented in Figure 11 and clearly shows the condition of the ceiling. It is apparent that the housing blocks moved against each other, with a tendency to fall into the tunnel interior (1 in radargram A, in Figure 11). The cementing zone behind the casing in some places may be up to 1 m thick (2a in radargrams A and B, in Figure 11), and the rocks are crushed after it (2b in radargrams A and B, in Figure 11). The loss of housing blocks inside the tunnel is also confirmed by visual observations of the tunnel walls. In order to temporarily stop the movements of the housing blocks, suitable wooden wedges have been hammered into the interstices between the blocks (Figure 12).

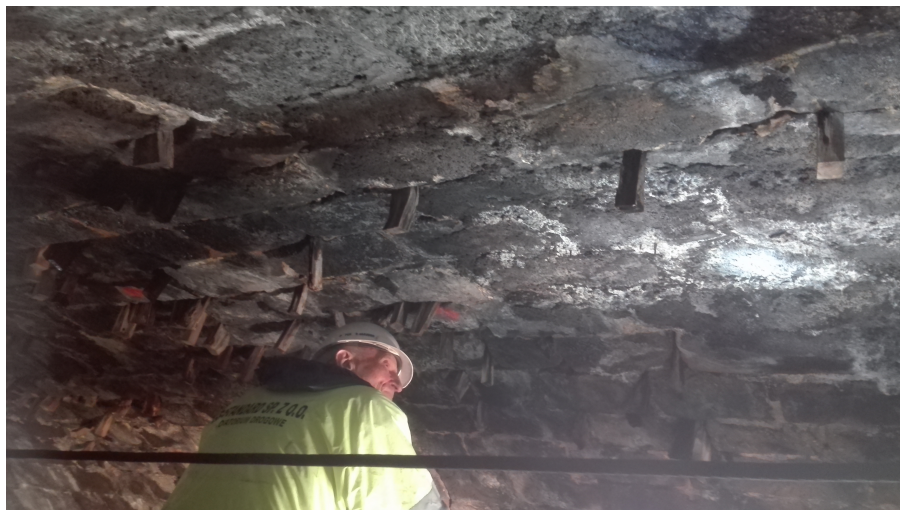
**FIG. 12** – Photo of the tunnel ceiling, showing the falling blocks of the housing and the wooden wedges hammered into fissures between blocks to temporarily stop their movements.

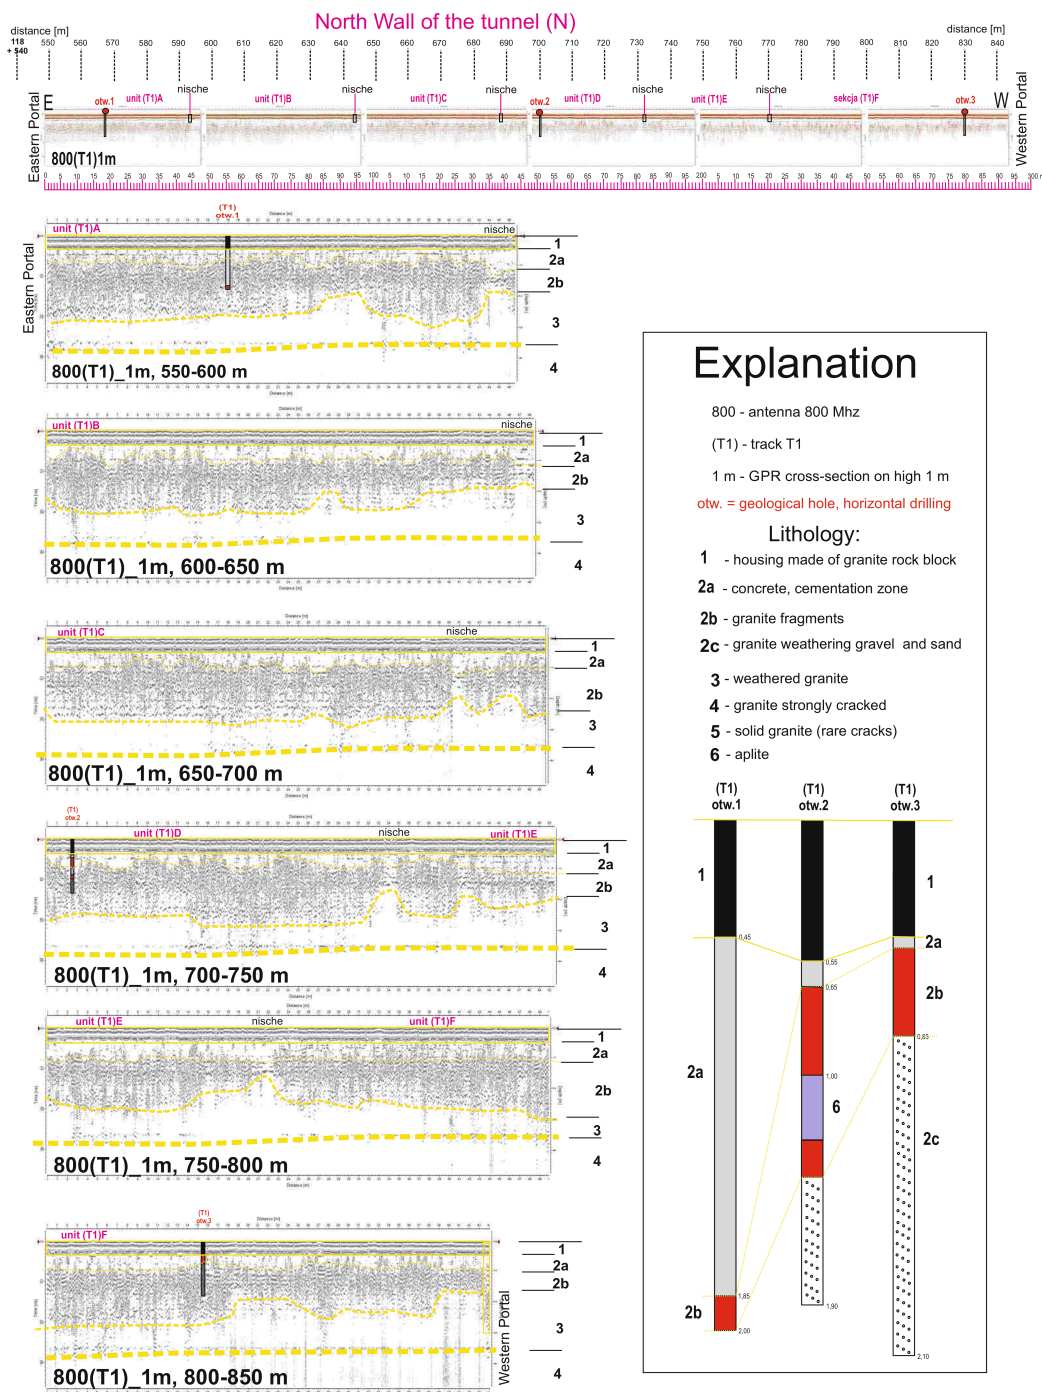
**FIG. 15** – GPR cross section obtained with 800 MHz antennas along the northern wall of the tunnel, at the T1 track and at a height of 1 m from the tunnel floor.

Finally, the data obtained by using the 800 MHz antennas clearly reveal the condition of the tunnel casing (1 in Figure 15), the cementing zone (2a in Figure 15), as well as the zone of weathered, gravel-sandy fillings (2b in Figure 15). The remaining boundaries are very poorly legible. A thorough analysis of data obtained from the 800 MHz antennas allows to visualize the gap widths in the tunnel casing (e.g., radargram A in Figure 6) and to illustrate the state of the tunnel casing blocks (e.g., radargram B in Figure 6).

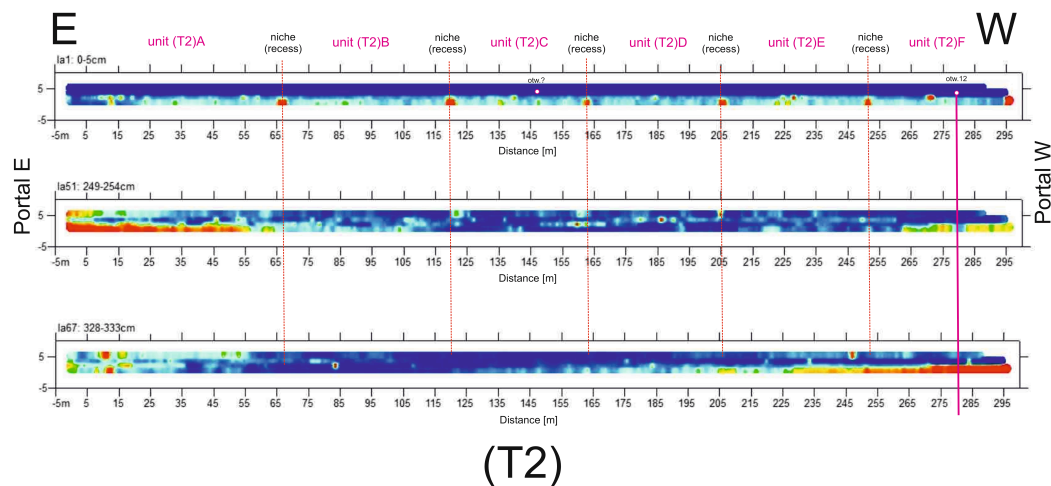
**FIG. 16** – Southern wall of the tunnel, T2 track. Selected time slices.

To illustrate the results of the analysis, examples are presented in Figures 16 and 17, for the southern and northern walls of the tunnel, respectively. In the figures, sections and locations of bores made in the tunnel walls have been marked. On shallow time slices (e.g., from 0-0.15 m) niches in the tunnel walls can be clearly noticed (red points). On these “horizontal” time slices, warm colors (red, orange, yellow) correspond to anomalous spots indicating loosening in the tunnel casing or behind the tunnel casing.

In particular, let us examine more in detail Figure 16, recorded on the southern wall of the tunnel along T2: three examples of time cuts were chosen, corresponding to depths of 0-0.05 m, 2.49-2.54 m, and 3.28-3.33 m. Very poor condition of the housing (red, orange, yellow hues) can be observed on the tunnel section 0-56 m (time slice at a depth of 2.49-2.54 m) as well as on the tunnel section 2.40-2.95 m (time slice at a depth of 3.28-3.33 m), i.e., near the eastern and western tunnel portal.

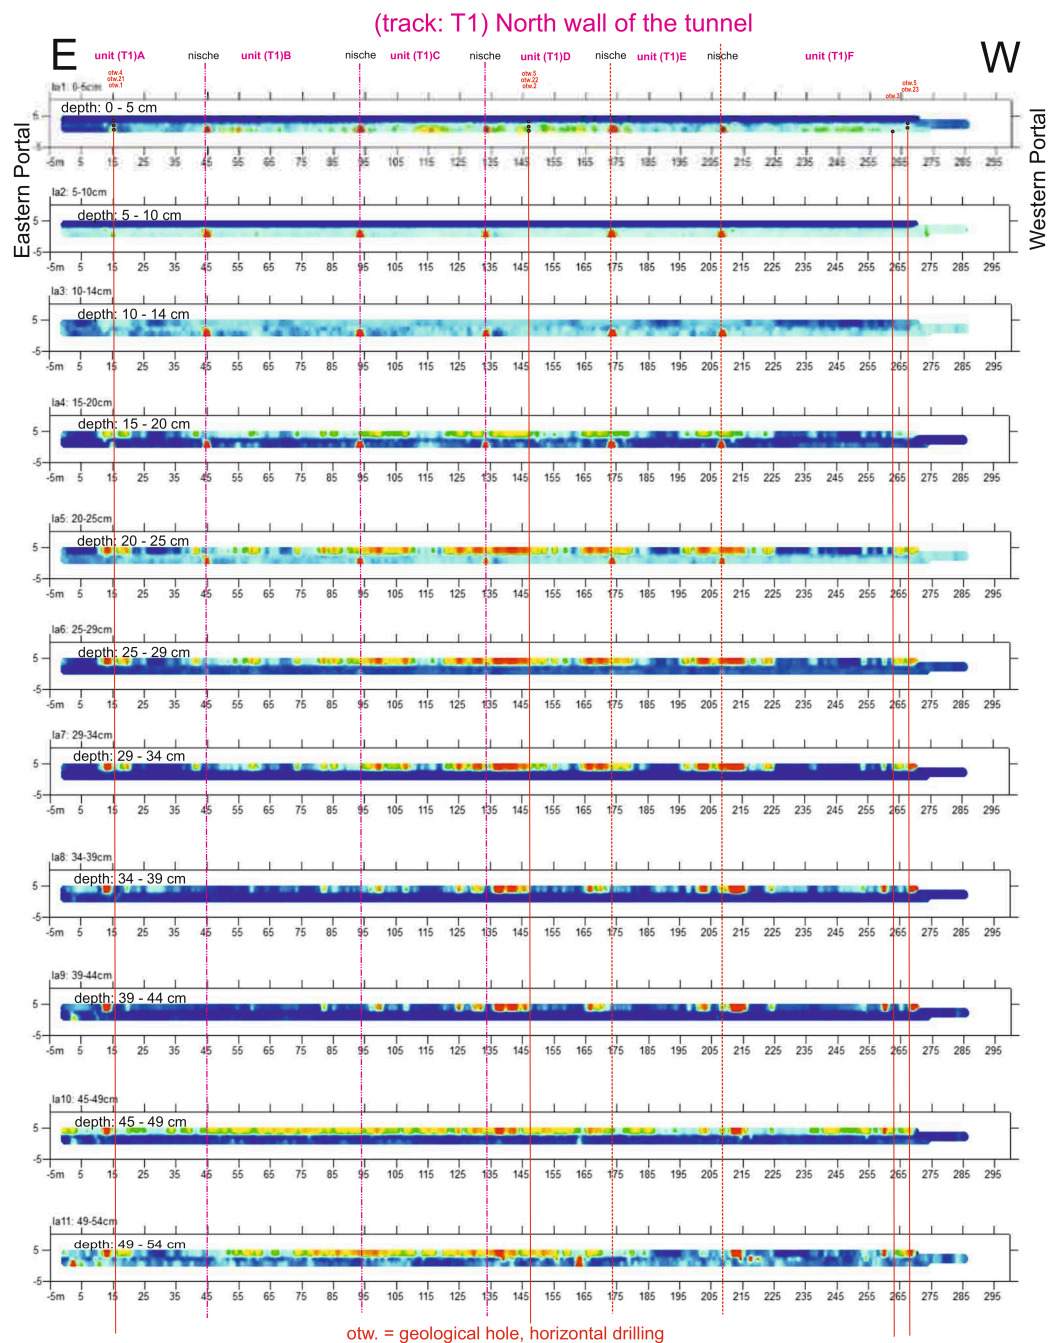
**FIG. 17** – Northern wall of the tunnel, T1 track. Selected time slices.

Let us now examine more in detail Figure 17, recorded on the northern wall of the tunnel along track T1. In this case, very poor condition of the housing is on the tunnel section 0.8-2.15 m (time slice for a depth of 0.2-0.5 m). The worst situation is observed on the tunnel section 1.2-1.75 m (cut at a depth of 0.2-0.44 m).
